THE RECOVERY, RECONSTRUCTION, AND ANALYSIS OF YENİKAPI 14 (YK
14), A MIDDLE BYZANTINE MERCHANT SHIP FROM THE THEODOSIAN
HARBOR EXCAVATIONS AT YENİKAPI, ISTANBUL

A Dissertation

MICHAEL RICE JONES

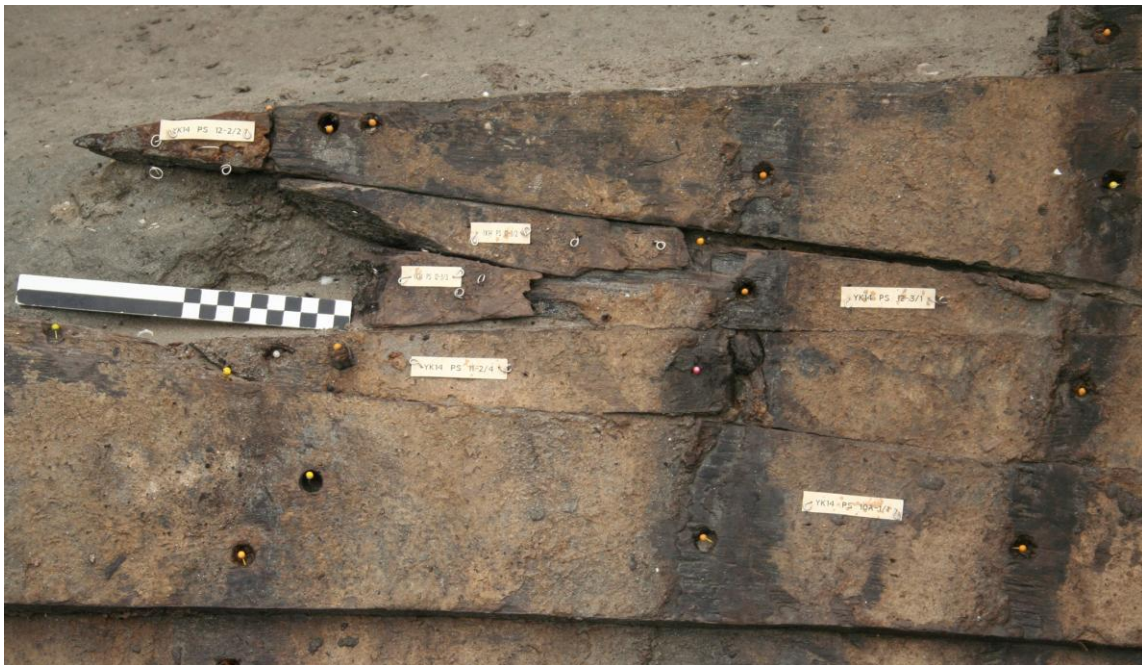
Figure 3.139: PS 11-2/6 in situ, a repair piece added to a scarf tip.

PS 11-2/6 is a 33.1 cm-long, narrow graving or filler piece at the forward end of PS 11-2/1-5 (**Figures 3.139-40**). The irregular surface on the forward end of PS 11-2/5 shows

that this piece was also replacing a rotten section of planking in the hull. An extra fastener hole, found concealed by pitch, was located in this piece at FL 43, in addition to a caulked drilled hole forward of the F 44 treenail. The forward end of PS 11-2/1-5 shows clear evidence of damage by rot at a coak hole, which must have precipitated the insertion of the repair plank. No evidence for coaks in the edges of PS 11-2/6 was found, making it unique among the repair planks in YK 14. The wood type (*Fraxinus excelsior*), is also unusual for a hull plank from YK 14. The caulking along the edges of PS 11-2/6, which contain long fibers pressed along the edges of the plank seam's outboard side along with thick pitch deposits, are likely examples of driven caulking deposits.

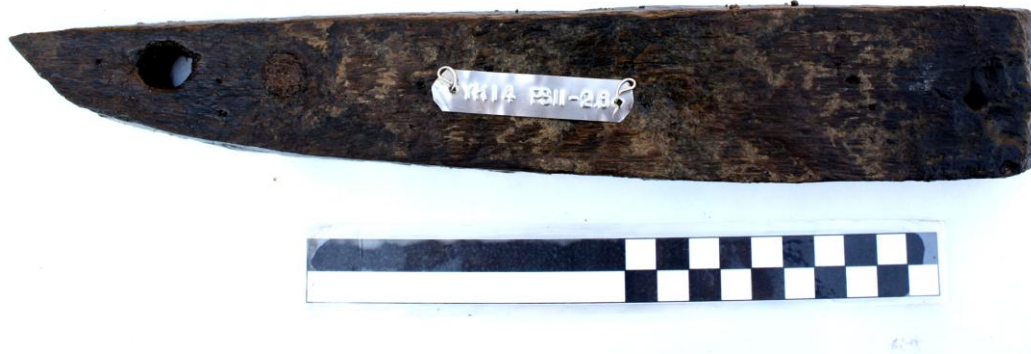
Figure 3.140: The inner face of PS 11-2/6 after cleaning.

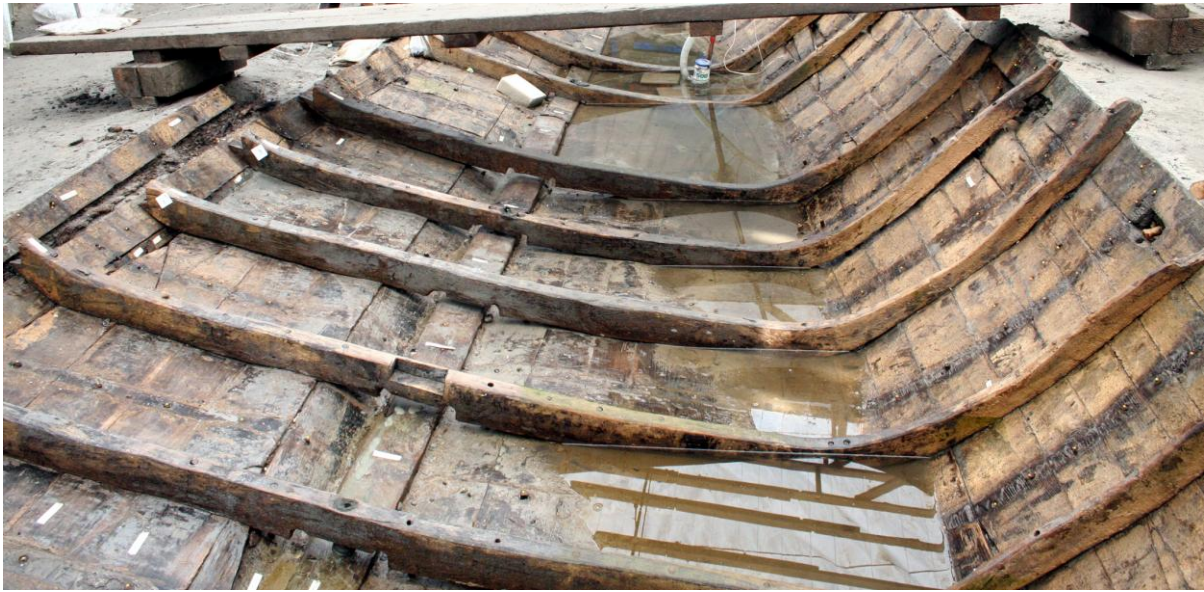
Figure 3.141: Floors 26, 28, 30, 32, and 34 in situ, during the dismantling of the ship, May 2007.

The floors used in the main section of YK 14 are fairly straight up to the turn of the bilge, with only a slight increase in the molded dimension in the area of the garboard strake before the limber holes (**Figure 3.141**). Floors were shaped from naturally curved compass timber, usually cut from one-half of a relatively young log with a protruding tree limb. Each timber was sawn longitudinally on one side.

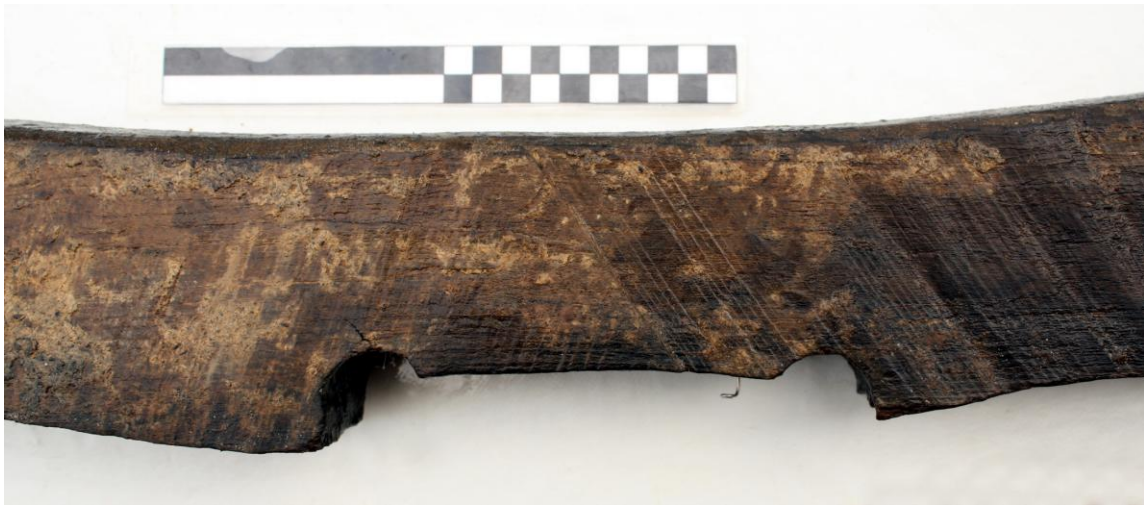
Figure 3.155: The flat, sawn faces of the floor timbers were cut from two different directions; the saw marks usually meet either before the turn of the bilge on the 'long arm' or in the keel area, shown here on FL 40.

extremities of the ship (e.g., FL 40) (**Figure 3.155**). Saw marks were usually somewhat regular except at these points where the saw marks crossed or at the locations of knots. Ten of the floor timbers (FL 6, 17, 19, 20, 31, 32, 34, 35, 37, and 41) and four of the futtocks (F 17, 27, 29, and 35) exhibit adze dubbing on their sawn faces, probably from removing of rough or splintered sections from the face. On both the floors and the futtocks, the dubbing tends to be found near the floor/futtock scarf ends. In the cases of FL 20 and 41, saw marks indicate that the timber was being sawn longitudinally from two different directions, but did not cross as on the other frames; the section between the saw marks in each direction was split away rather than finished with an adze. On F 29, a deep depression was cut rather roughly with an adze to allow the futtock to be placed next to an adjacent through-beam, which must have already been in place when the futtock was being installed (**Figure 3.156**).

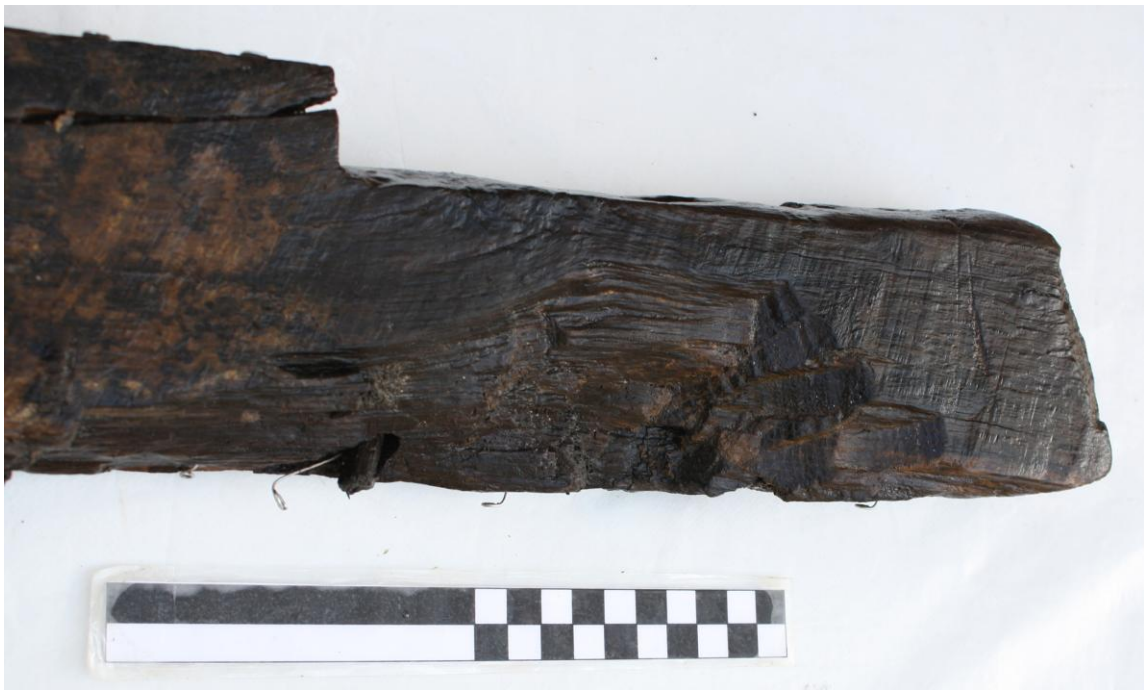
Figure 3.156: Adzed depression on F 29 cut to fit the futtock around an adjacent through-beam.

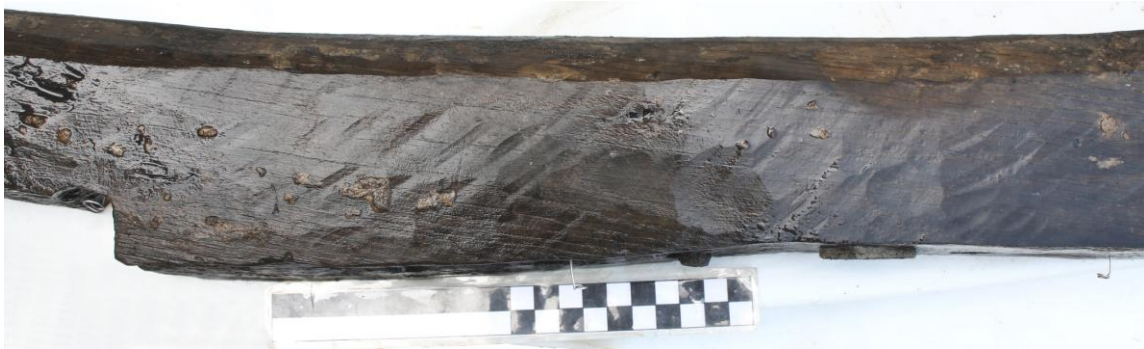
Figure 3.157: Forward face detail of FL 40 showing well preserved adze marks.

The other three faces of the frames in nearly all cases were shaped with adzes (**Figure 3.157**). The inner face edges of the floor and futtock timbers on most frames are chamfered, with a single small chamfer on the edge between the sawn face and the inner face; the chamfers range in width and depth from 0.1 to 1.6 cm, but are usually about 0.5 cm wide and 0.5 cm deep. The opposite corner is usually shaped into a larger, more rounded chamfered surface, usually consisting of three chamfers, whose widths and heights range from 0.8 to 5.3 cm (**Figure 3.158**).³⁶⁵ These chamfers often exhibit large sections of rounded, un-worked areas of the timber where only the bark was removed. Individual tool marks, typically 2-3 cm long and sometimes exhibiting the striations typical of adze marks elsewhere in the hull, are clearly visible on all of these chamfers. These tool marks indicate that they were cut with an adze rather than a plane or drawknife; both tools would leave a smooth, continuous chamfer rather than the interrupted ones seen on the frames. Also, striations from nicks or irregularities in the tool's blades are visible on many of these tool marks, showing that they were made by blows struck at an angle, rather than parallel to, the lengths of the timbers.

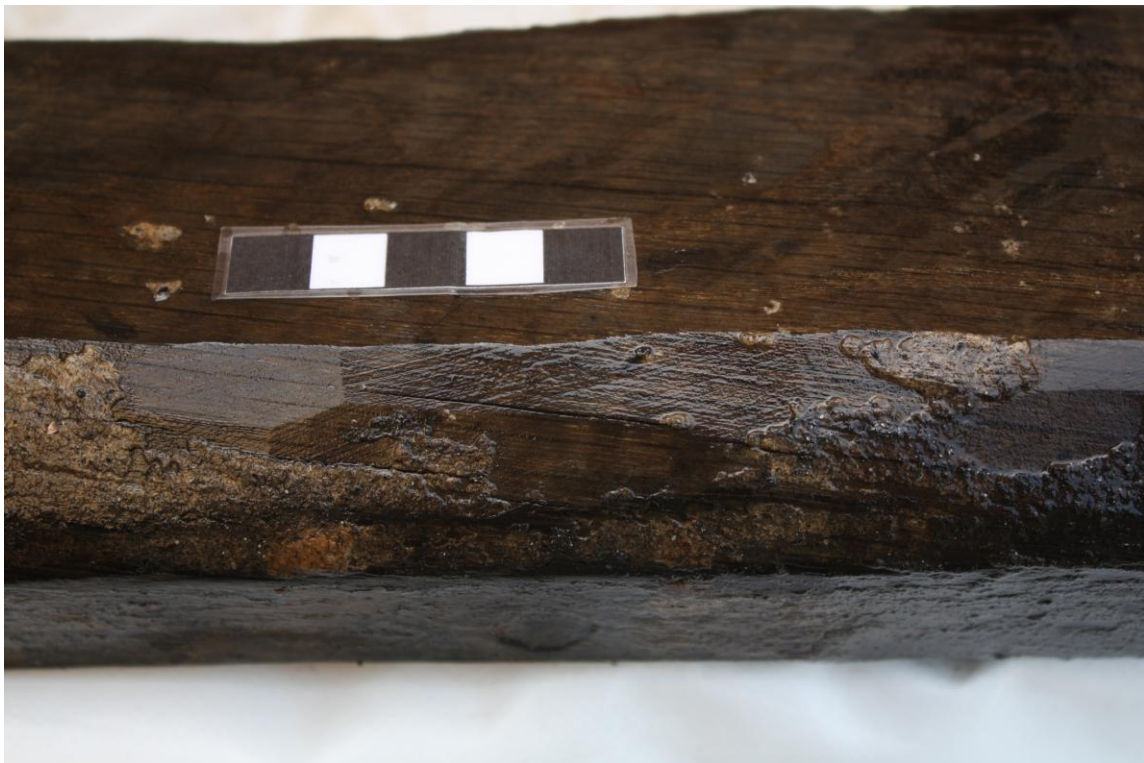
Figure 3.158: Adze marks on the inner face/forward face chamfer on FL 40.

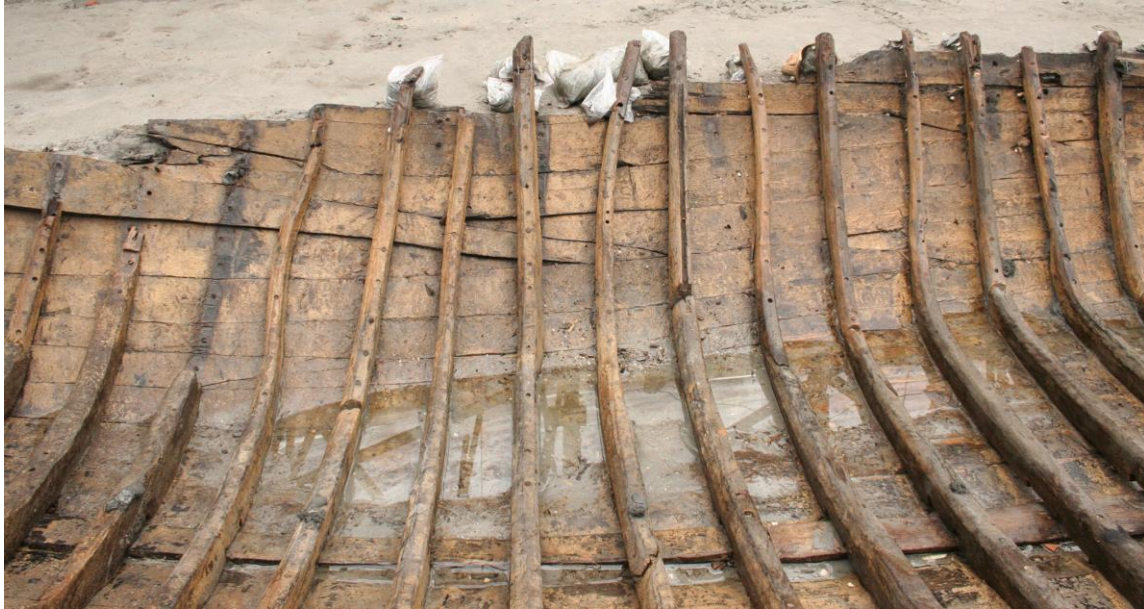
Figure 3.159: Floors with curved and irregular 'long arms' preserved on the starboard side of the ship.

curvatures or undulations in the frame beyond the turn of the bilge, and exhibit only minimally worked surfaces; often only the bark was removed from the surfaces of the floor in this area, but little else (**Figure 3.159-60**).

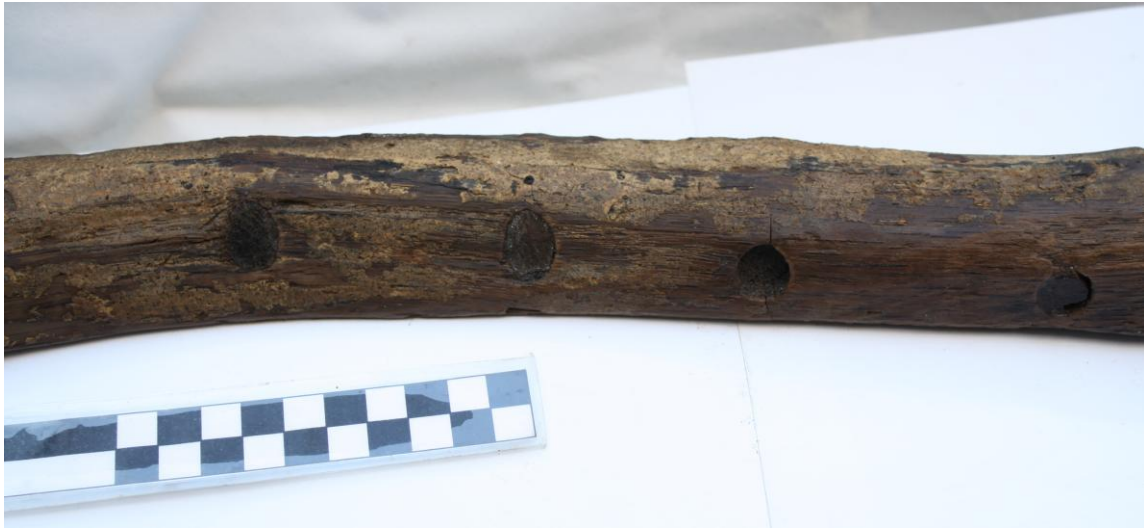
Figure 3.160: Detail of the minimal working of the 'long arm' of FL 30 above the turn of bilge.

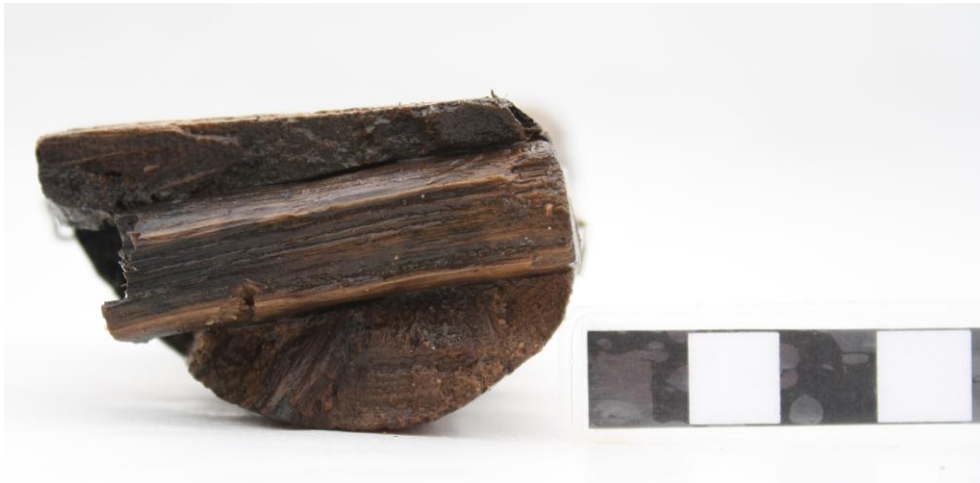
Figure 3.161: A treenail at a break in the 'long arm' of FL 22 above the turn of the bilge. Note the small cross section of the floor timber at this location.

The upper ends of the 'long arms' are especially light: on many floors the treenails driven through the upper part of the 'long arm' timber run through half of the diameter of the timber (**Figure 3.161**). This probably accounts for why stringer ST-1 was fastened only to futtocks; at the level of the waterline, the floor timbers are too slender to be fastened to another timber.

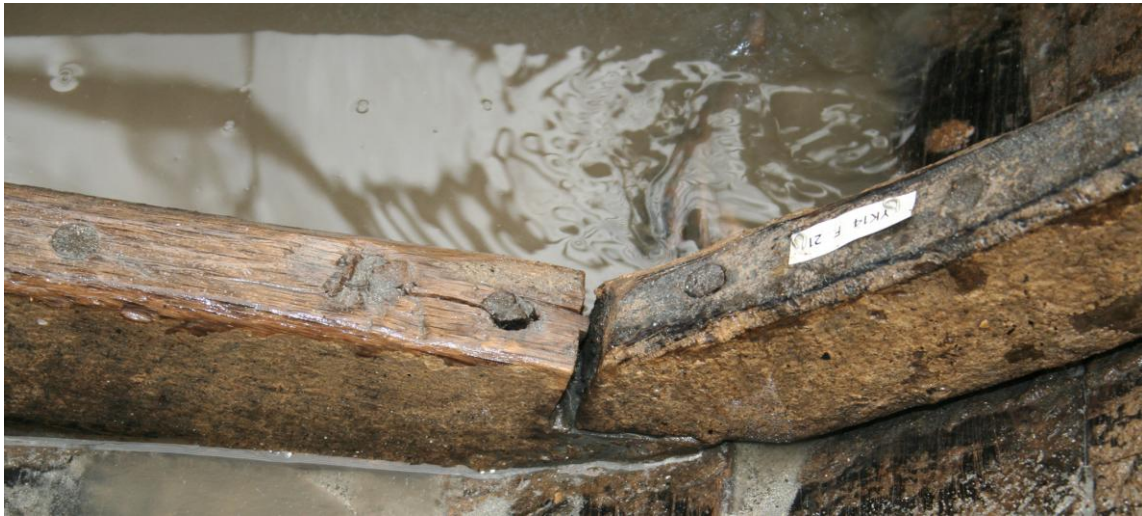
Figure 3.162: Floor/futtock scarf between floor FL 21 and futtock F 21.

YK 14's futtocks were scarfed to the floors in an unusual way. The inboard ends of futtocks were cut into bevels in order to fit tightly into scarf ends cut into the 'short arm' ends of the floors (**Figure 3.162**).

A thin, protruding section was usually left in place on the outboard section of the floor at the scarf's location; these protrusions are quite delicate, serve no structural purpose, and could not be easily produced outside of the hull. These features were probably made by sawing with a small handsaw inside the hull (an adze or chisel would have caused more damage to the floor ends) although no damage from the ends of a saw were found along the bilge planks. Unfortunately, the original surfaces of many of the scarf ends were damaged by wood rot, so that tool marks are not clearly distinguishable on these protrusions. Where they are preserved, they indicate that the vertical faces of the floor scarfs were often sawn, but others exhibit adze or chisel marks, probably from trimming the scarf surfaces after the initial sawing for a tighter fit between the floor and futtock (**Figures 3.163-65**). The horizontal faces of the scarf ends showed more variation. Some were cut smooth and display visible adze or chisel marks (again, probably from trimming of the scarf face after the initial sawing of the scarf), while others were roughly shaped by multiple saw cuts or splitting. The inboard ends of the futtocks were cut with

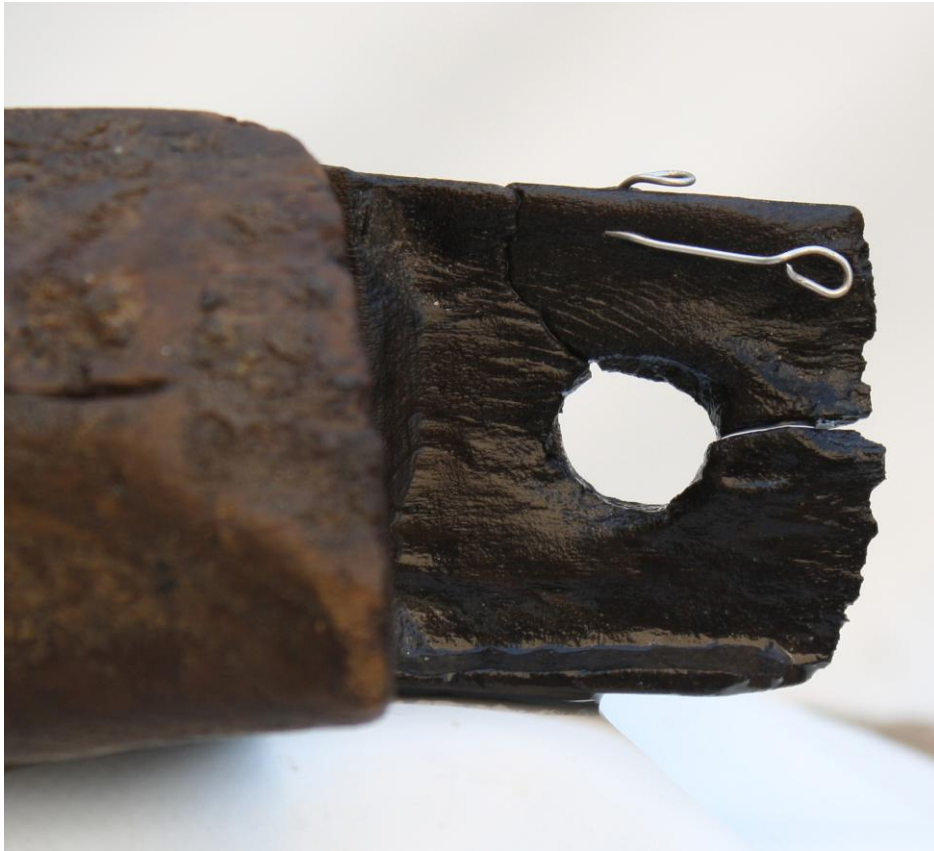
Figure 3.163: Horizontal face of futtock scarf on floor FL 23, damaged by wood rot.

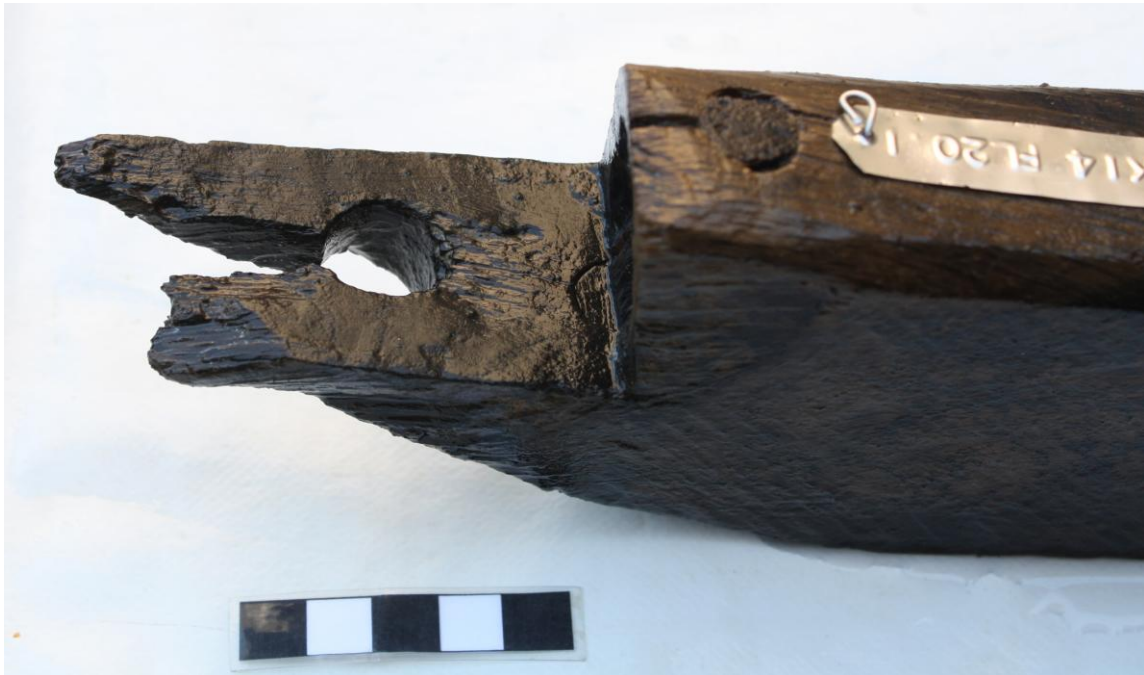
Figure 3.164: Horizontal part of the floor/futtock scarf on FL 20. Note the cut marks and the treenail that was partially cut at the right corner of the notch.

The scarf ends are sometimes cut through treenails fastening the floors to the planking, another sign that the floors must have already been installed in the hull when the futtocks were inserted. Cut treenails were found in the scarf ends of FL 15, 16, 18, 20 and FL 37. In many other cases the floor and futtock timbers are fastened at the location of the scarf end with a treenail or (rarely) a nail, but the fasteners are used to fasten the futtock to the planking rather than the floor to the futtock.

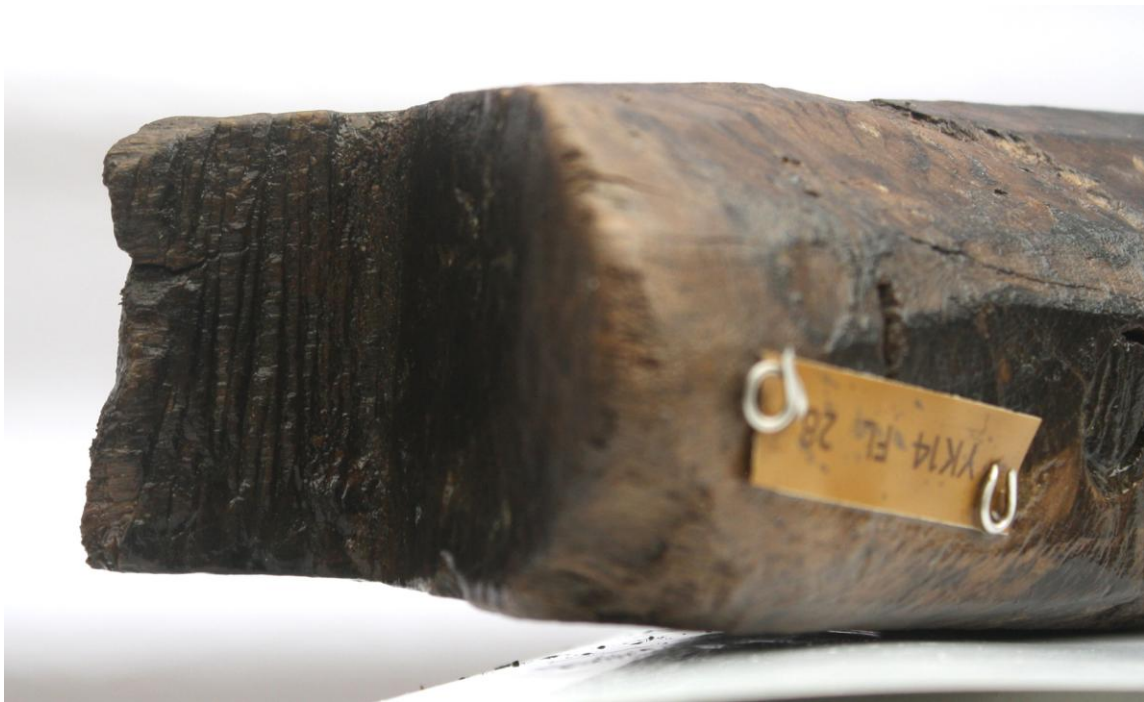
Figure 3.165: Tool marks, probably a series of angled saw or chisel cuts, on the horizontal face of the floor/futtock scarf on FL 28.

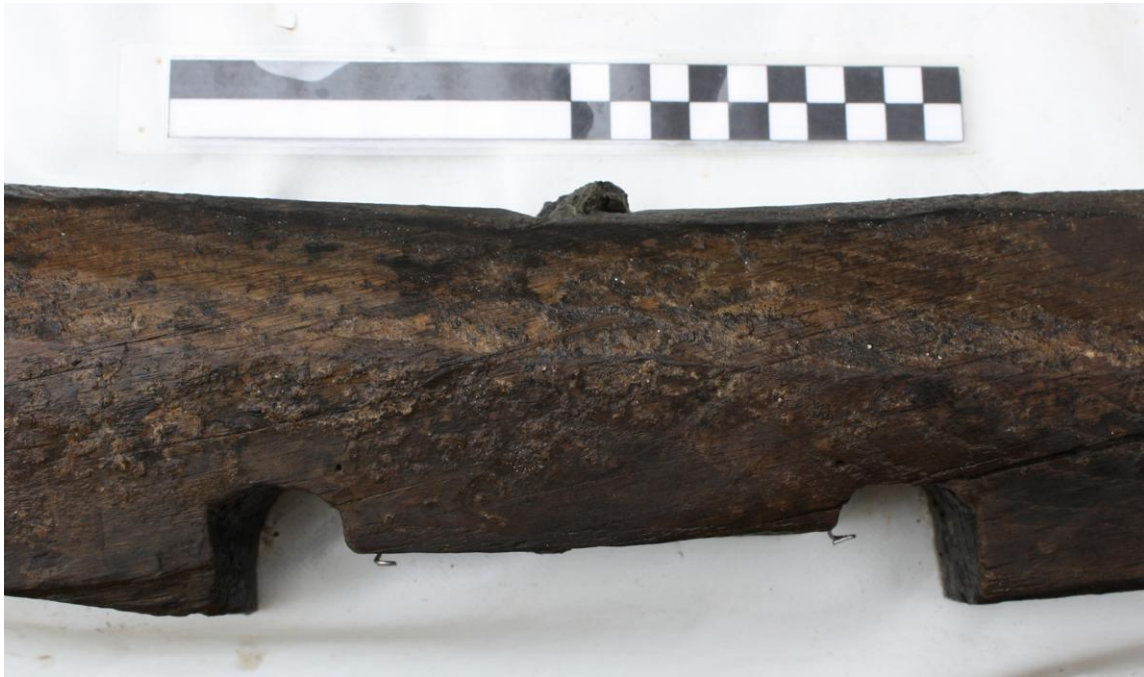
Figure 3.166: Forward face view of the limber holes on FL 38, which are typical of the limber holes on most of YK 14's floor timbers.

All but one of the 45 surviving floor timbers was provided with a pair of limber holes on either side of the keel. Limber holes were made in two different ways. The more common type has straight, sawn sides and a rounded, arch-like top (**Figure 3.166**). The straight sides of these limber holes were cut with a saw while the rounded top section

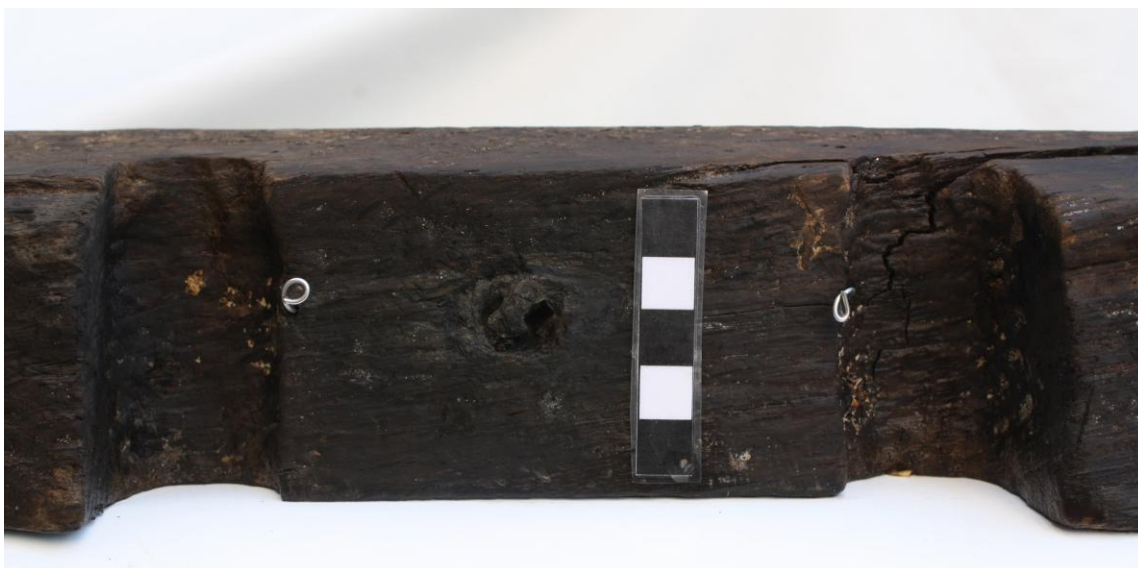
Figure 3.167: Outer face view of limber holes on FL 38. Note the keel nail concretion in the pilot hole at center.

may have been shaped with a chisel or perhaps several drilled holes (clear tool marks generally do not survive in the upper sections of the limber holes) (**Figures 3.167-68**).

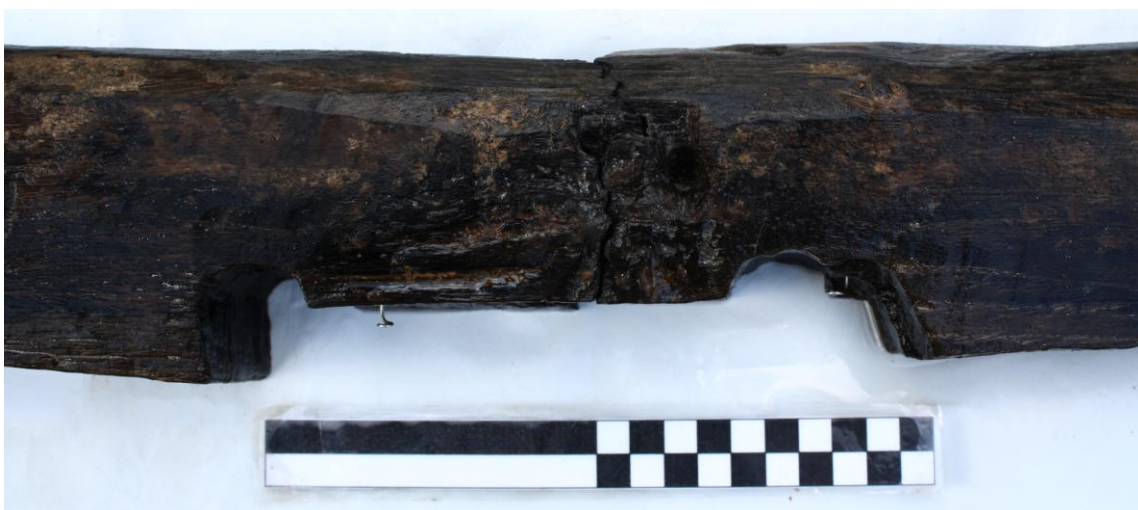
Figure 3.168: Forward face view of limber holes on FL 29. The port limber hole (right) was expanded to fit over the inner face of the keel.

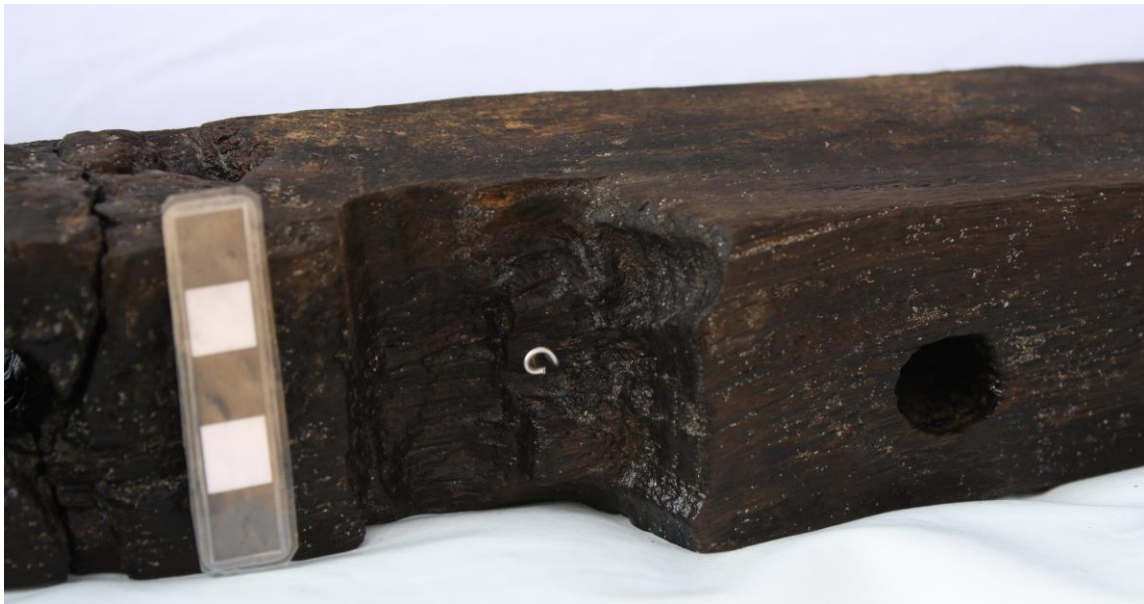
Figure 3.169: Oblique view of the expanded limber hole on FL 29.

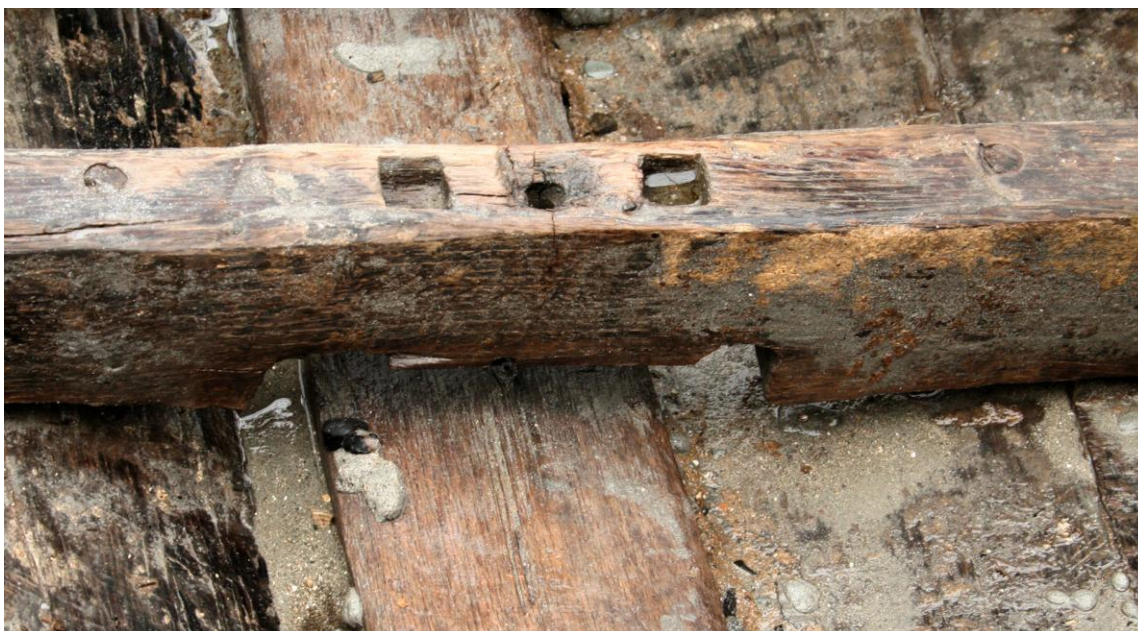
Figure 3.170 Alignment of limber holes on FL 29 over the keel before its removal from the hull. The port side and the 'expanded' limber hole are to the left.

The limber holes on the floors were aligned in the hull in a particular way. The inboard edges of the starboard limber holes were closely aligned with the starboard edge of the keel's inner face, while the 'expanded' limber holes appear only on the port side of the frame, and were much more crudely-shaped; the other limber holes on the port sides of the floors are misaligned on nearly all of the floor timbers. Because the limber holes were cut at varying distances from each other, only the limber holes on one side could be closely aligned with the edge of the keel's inner face. The 'expanded' limber holes were widened because they were cut on certain floors before they were installed and were thus too close together to fit over the protruding inner face section of the keel (**Figure 3.170-71**).³⁶⁹ The limber holes may have been lined up on the starboard side of the keel for a functional reason; perhaps it made the process of shaping pairs of floors simpler. Although the floors were shaped in a fairly standardized way, measurements seem to have been approximate for the limber holes and likely other features as well, such as the total length of the floor timbers and their exact curvature in the hull.

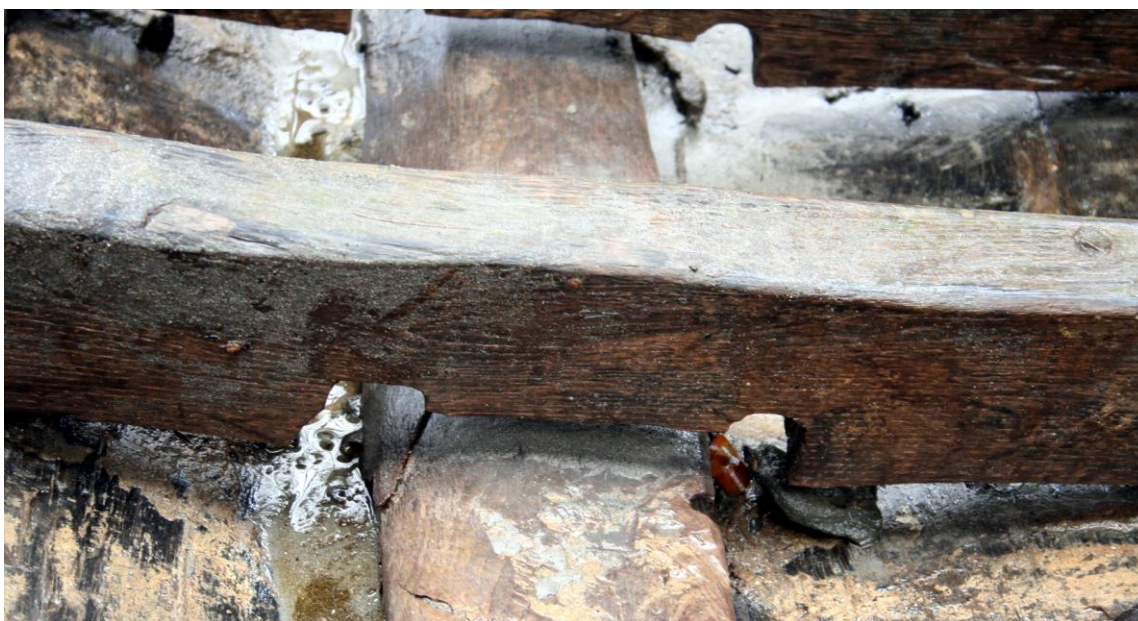
Figure 3.171 The limber holes on FL 33 in situ, viewed from the aft sawn face of the floor. The starboard limber hole is closely aligned with the starboard edge of the keel, while the port side limber hole required re-shaping in order to fit over the port side of the keel's inner face.

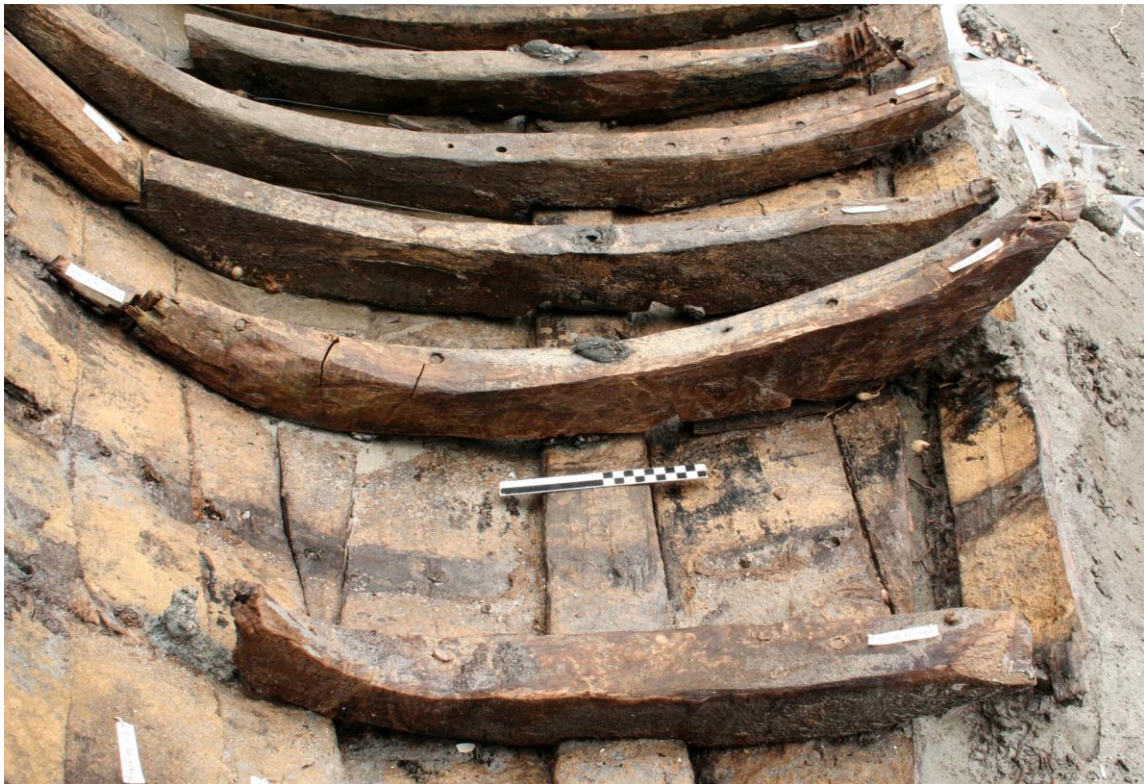
Figure 3.172: FL 44-48 in situ. Displaced floor FL 48, in the foreground, has been moved back to its original position for the photograph. The wedge or shim below FL 46 is visible under the limber holes cut over SS 1-3.

Limber holes on six of the floors at either end of the ship were triangular in shape (FL 4, 5, 43, 44, 45, and 46); they were cut with an adze or chisel, and the forward and aft face edges of the cuts were usually chamfered. Limber holes of this type ranged in width from 2.4 to 3.8 cm wide and 1.0 to 2.8 cm deep. One surviving floor timber, FL 48, was notched over the keel but did not have limber holes, apparently because it was high enough in the hull not to require them (**Figure 3.172**). Another unique floor timber is FL 46. Triangular limber holes were cut in the area of SS 1, probably before the timber's final location in the hull was chosen, and a shallow depression was cut in the area where the frame was finally fastened to the keel. A shim or wedge was fastened between the floor timber and the planking in the SS 1 area so that the floor could be solidly fastened to the garboard strake (**Figure 3.173**).

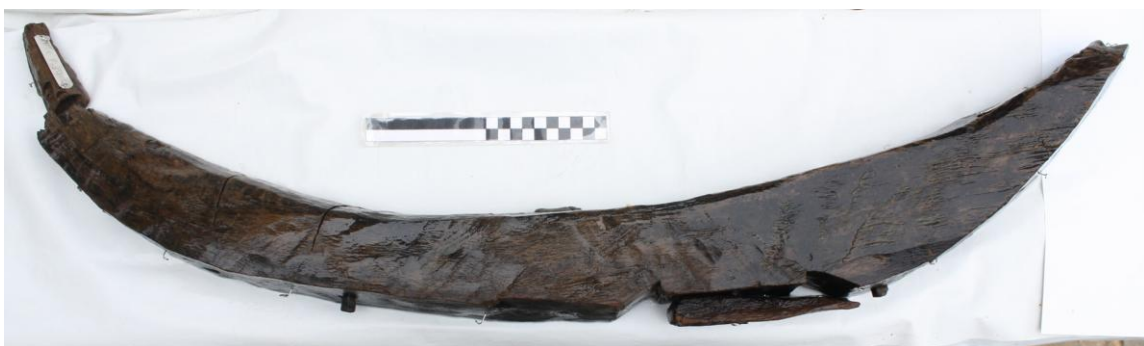
Figure 3.173: Forward face of FL 46. Note the limber holes and wedge (fastened in its original position) in the port garboard (SS 1) area of the outer face of the floor. The keel area of the floor is a shallow cut depression to the left of the limber holes in the photograph.

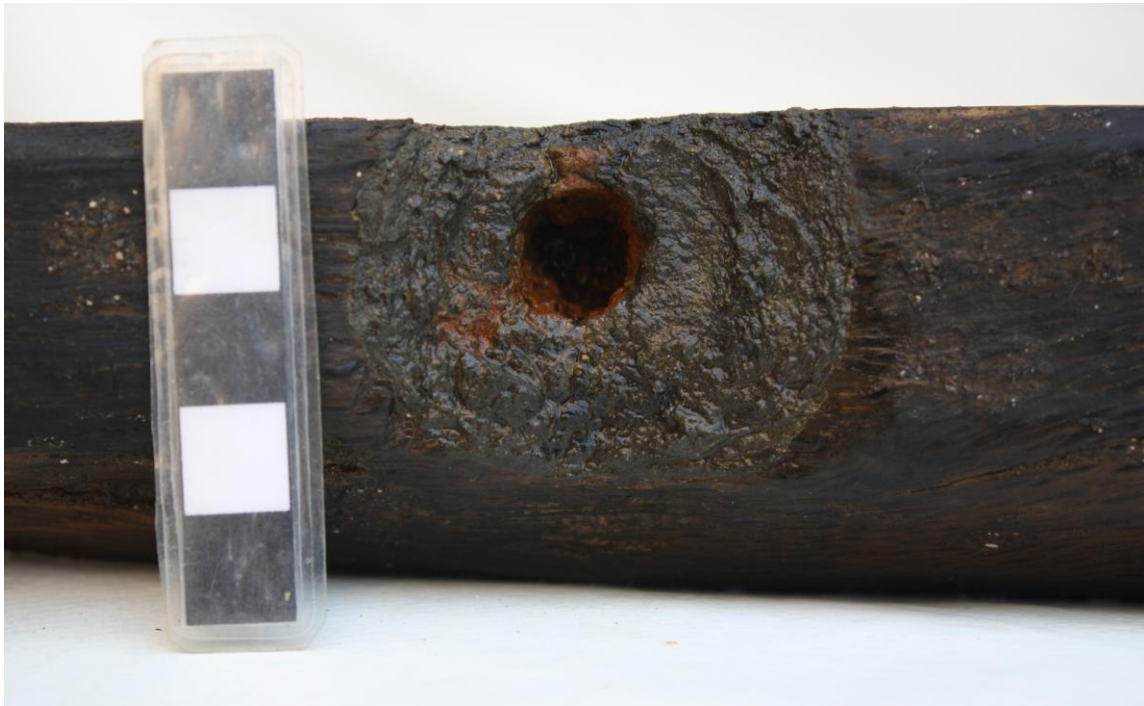
Figure 3.174: FL 12, keel nail concretion on the inner face.

The frames are fastened to each strake with one to three treenails; one or two treenails is typical, depending on the width of the plank and its location in the hull. Iron nails were typically used singly, although in a few instances two nails were used as frame fasteners at a single strake, usually as repairs. Evidence from the surviving floors and fastener holes in the inner faces of the keel timbers indicate that 20 or 21 of the estimated 51-52 floors were nailed to the keel.³⁷⁰ No treenails were used to fasten floor timbers to the keel. The keel nails were driven through pre-drilled pilot holes, which penetrate the thickness of the floor timber from the inner to the outer face; no evidence of treenails were found in these holes, which instead contained nail shafts and iron concretion. On 14 of the 19 surviving floors nailed to the keel (FL 9, 12, 14, 17, 20, 23, 26, 29, 38, 41, 43, 45, 46, and 47), a recess was cut in the inner face for the nail head (**Figures 3.174-75**). Some are too small and deep to have been cut with anything other than a chisel, but, in a few cases (FL 9, 45, and 46), the wide and shallow countersinking was probably cut with an adze. The countersunk areas range in length from 2.2 to 6.6 cm, in width from 2.2 to 5.3 cm, and are from 0.3 to 1.2 cm deep. The remaining keel nails were driven without countersinking recesses for the nail heads, although some of the nail heads left impressions in the inner face surfaces of the floors.

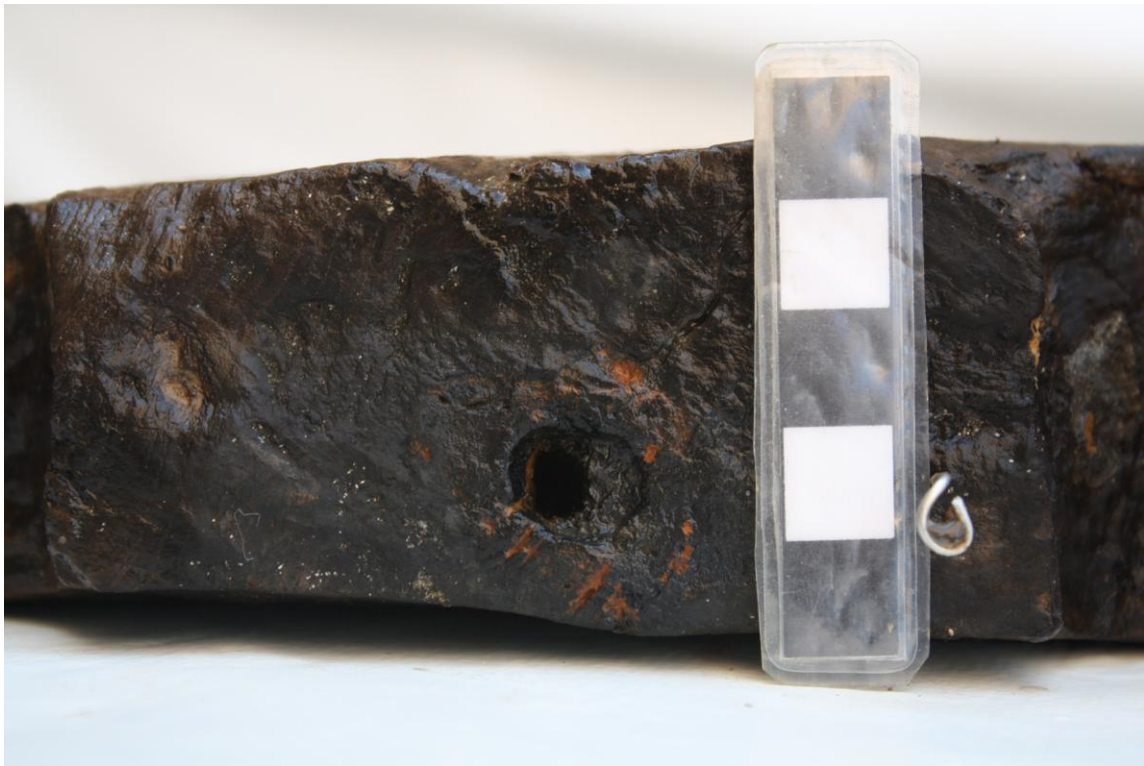
Figure 3.176: Nail concretion in a clearly-defined pilot hole on the outer face of FL 12.

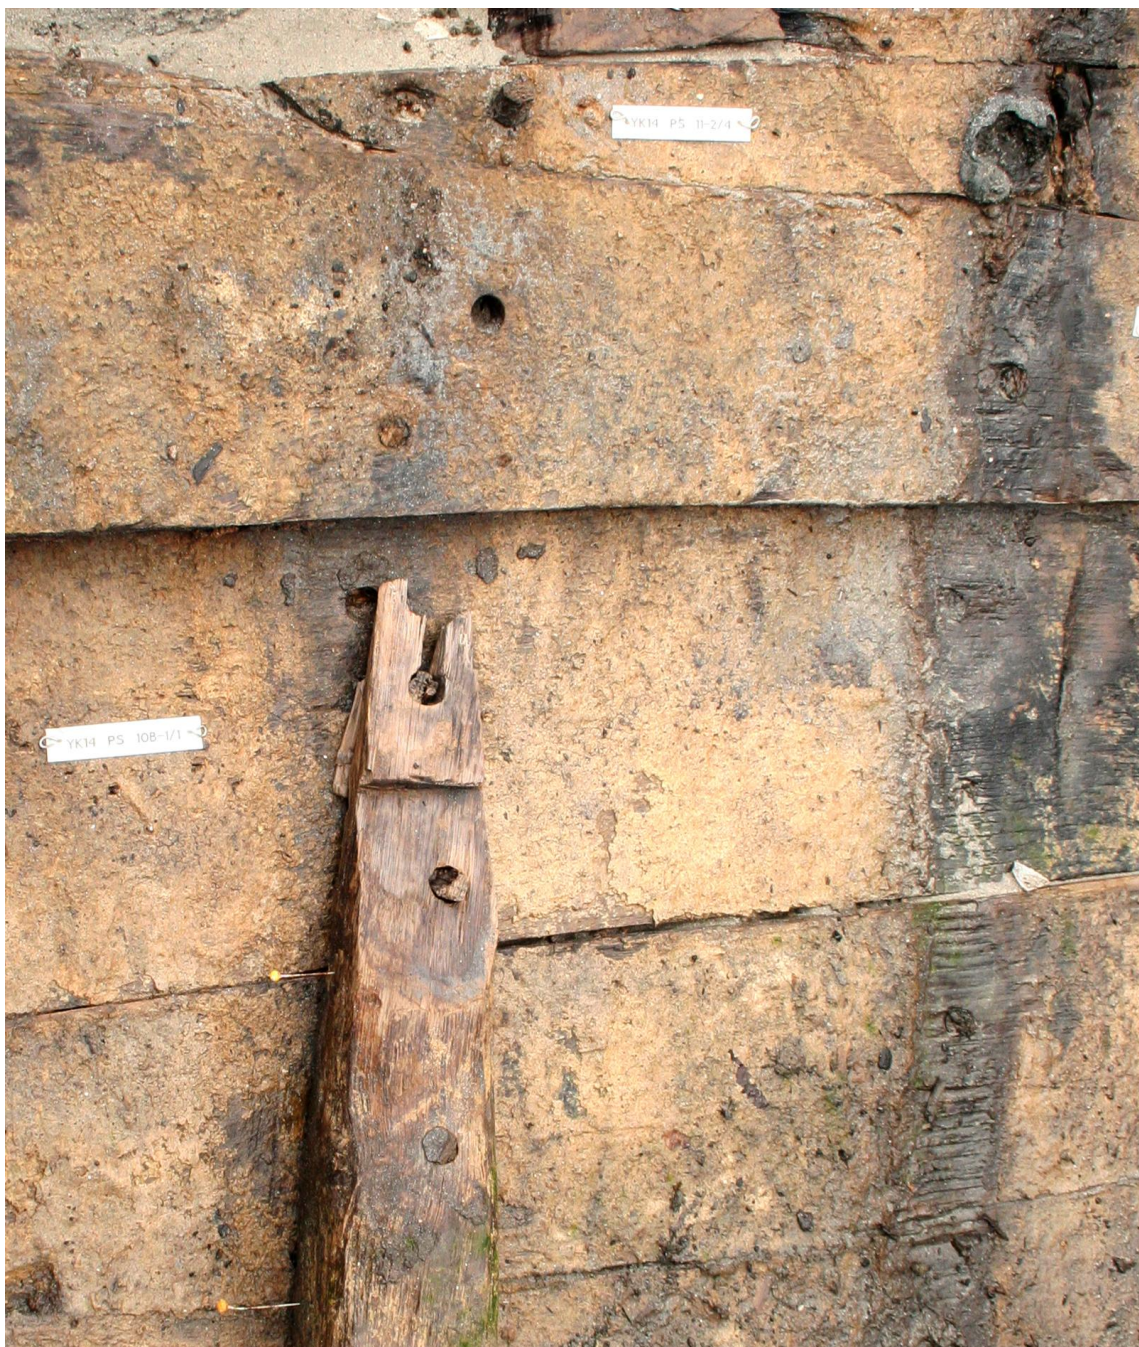
Figure 3.177: Hook scarf on the starboard end of FL 44. Note the caulked holes in the planking just forward of FL 44.

Several features of FL 44 and its location in the hull are unique, suggesting its possible origin as a repair component. FL 44 is the only floor timber with scarfs on both its port and starboard ends. The port end is cut into a somewhat crude L-shaped floor/futtock similar to those seen on nearly all of the other surviving floor timbers, while its starboard end terminates in a 17 cm-long hook scarf, the only one of its kind used in the ship on frame timbers; this scarf joined futtock F 44, now lost (**Figures 3.177-78**). FL 44 is the only frame from YK 14 with no sawn faces; all of its faces were worked with an adze. A

nail hole on the inner face of the keel under FL 44 does not correspond to a fastener on the frame, but it is aligned with several caulked drilled holes in planks PS 1-2 and SS 2-2 in the area of the frame. This suggests that a futtock or frame (either a temporary cleat used during construction or an original frame that was replaced by FL 44) may have been previously installed in this area of the hull. A row of caulked holes in the planking between PS 10B, 10A, and PS 12-2 are located just forward of the fasteners for the missing futtock F 44; these indicate that another futtock or the 'long arm' of a floor was once found in this location as well. If FL 44 corresponds to a later repair, it is possible that some of the original fastener holes for the treenails were used to fasten it in place, since there are not enough 'blind' fasteners in the planking at this frame. It seems more likely that FL 44 was the only available compass timber with the correct curvature for this specific location in the hull during construction, and was scarfed to a futtock on the starboard side because a longer floor timber was unavailable.
